Manhole Inspection Summary

Manhole # **S15GG_001MH**

Insp Date: **9/19/07 3:58 PM**

Location Address: **2603 BRADDISH AVE**

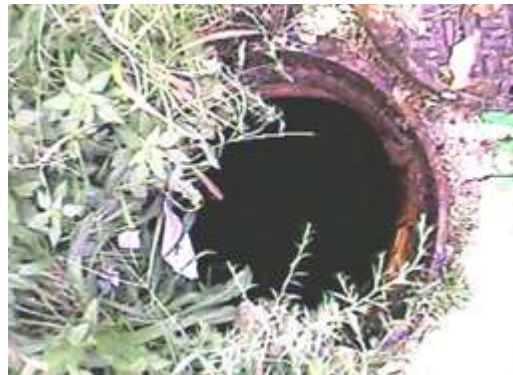
Defect 2

Frame Offset: **3** (in.) Condition: ☒ Sound ☐ Cracked ☐ Leaks

Chimney / Frame Adjustment ☒ Exists Material: **Brick and Concrete** ☐ Parged Height: **2** (in.)

loose bricks frame adjustment and offset frame

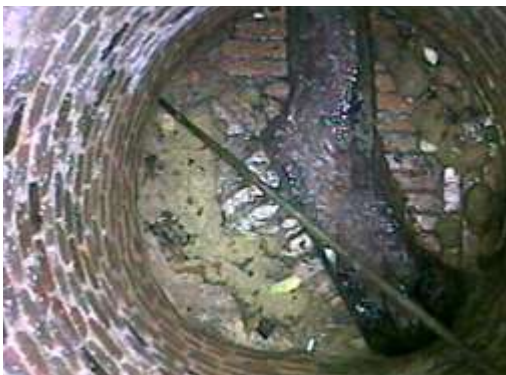
Defect 1

evidence surcharge

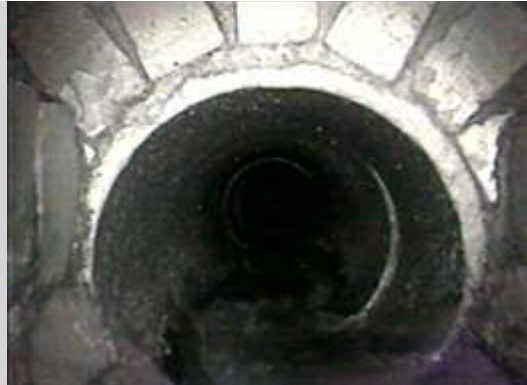
12 O'Clock Outflow

10 in. Circular Gravity Sewer
Pipe Out @ 12 O'Clock

Pipe Height: (in.) Direct
Pipe Material: **Clay** ☐ Pipe Lined
Invert Depth: **7.50** (ft.) Flow Characteristics: **Fast**
Deposits: ☒ None ☐ Mud ☐ Sludge ☐ Debris ☐ Grease
Silt Depth: (in.) Deposits Extent:
Infiltration: **None** Pipe Seal Cond: **Sound**

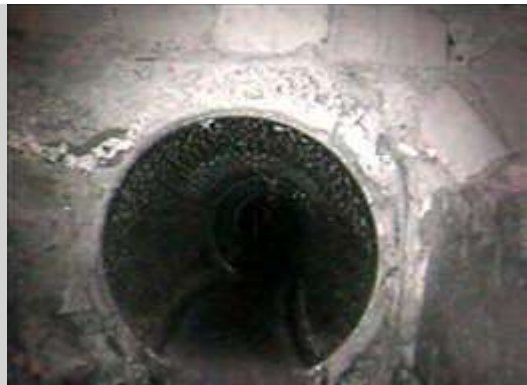
5 O'Clock Inflow

10 in. Circular Gravity Sewer
Pipe In @ 5 O'Clock

Pipe Height: (in.) Direct
Pipe Material: **Clay** ☐ Pipe Lined
Invert Depth: **7.34** (ft.) Flow Characteristics: **Fast**
Deposits: ☒ None ☐ Mud ☐ Sludge ☐ Debris ☐ Grease
Silt Depth: (in.) Deposits Extent:
Infiltration: **None** Pipe Seal Cond: **Sound**
